CORROSION BEHAVIOR OF METAL MATRIX COMPOSITES

R.C. Paciej and V.S. Agarwala
Air Vehicle and Crew Systems Technology Department
NAVAL AIR DEVELOPMENT CENTER
Warminster, PA 18974

FEBRUARY 1987

FINAL REPORT

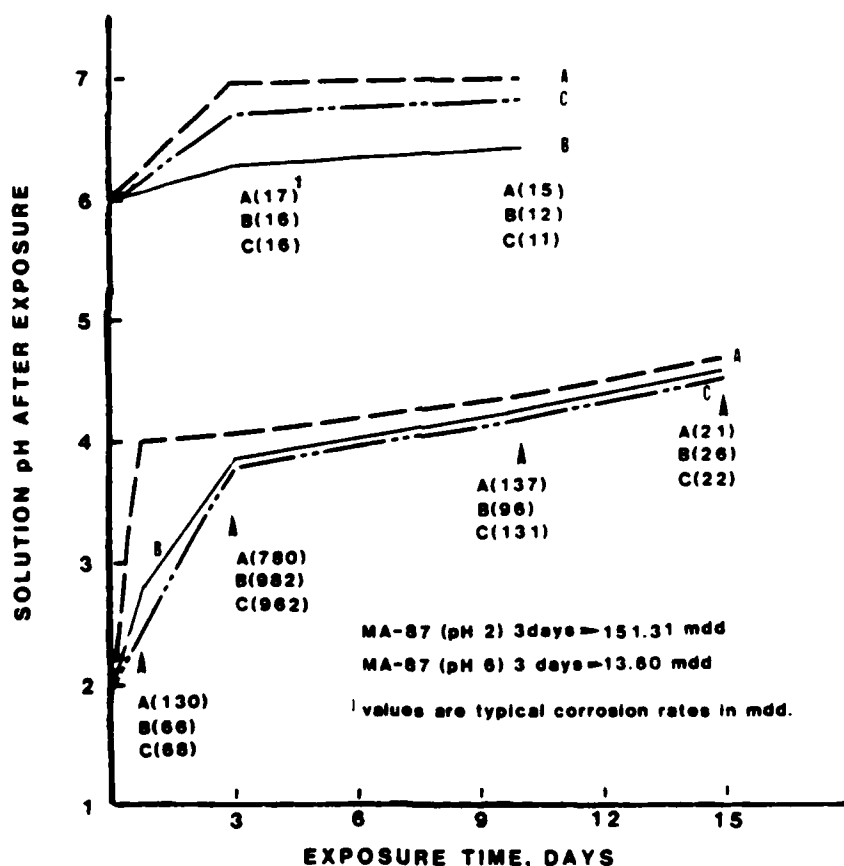
Figure 1. Effect of pH on Corrosion rates of the MMC and the MA-87 specimens with exposure time in pH 2 and 6, 3.5% NaCl.

Figure 1 shows plots of solution pH versus exposure time, and corrosion rate for each material. In both pH 2 and 6 solutions, the corrosion rates of MMC increased rapidly as the exposure time was increased to three days. Correspondingly, the pH of both the solutions also increased. A decrease in corrosion rate was observed for all specimens as the exposure time was increased to 15 days with only a slight increase in solution pH for each solution. The rate of increase of the solution pH appears to correlate with the change in corrosion rate. This indicates the pH sensitivity of the MMC's to corrosion. Overall, the temper A (as-received MMC) had the highest corrosion rate, followed by temper B then C. The MA-87 alloy had the lowest corrosion rate over a three-day exposure.

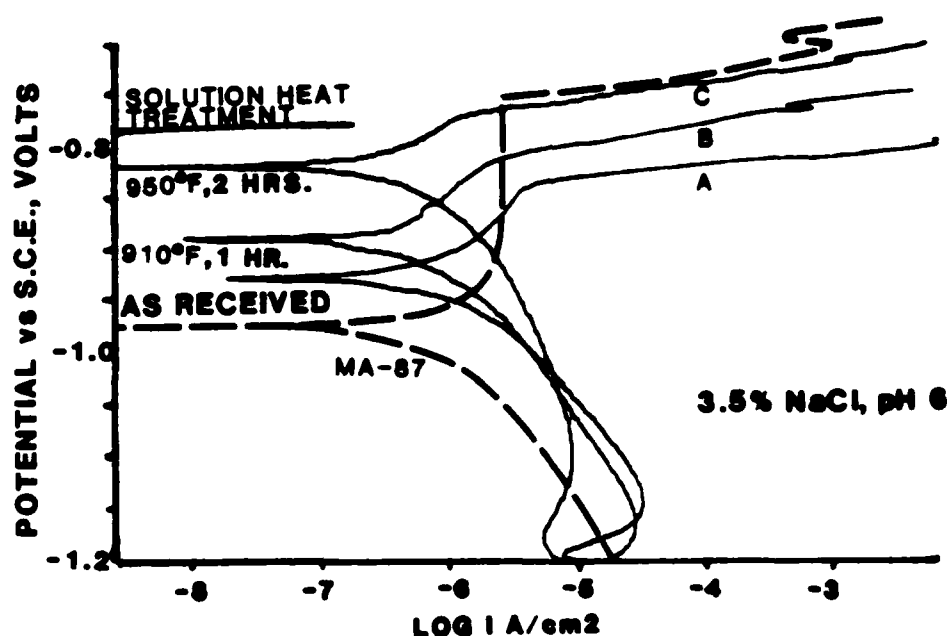
Figure 5. Potentiodynamic polarization behavior of the MMC and the MA-87 Al alloy specimens.

The potentiodynamic polarization behavior for the MMC and the MA-87 alloy in pH 6 solution are given in Figure 5. Typical values of potentiodynamic parameters are summarized in Table 4 and 5 in pH 2 and 6 solutions, respectively. In pH 2 solution, MMC of tempers B and C have slightly lower corrosion current densities than for temper A. This order corresponds with that of the corrosion rates determined from the weight-loss measurements. In pH 6 solution, temper A exhibits a more active potential $E(I=0)$ and more negative pitting potential than for tempers B and C. Of the three MMC tempers, temper C shows the least negative $E(I=0)$ and pitting potential. These parameters are very significant and uniquely shown how modification in solution heat treatment can alter the corrosion behavior of a MMC. In pH 6 solution, MMC of temper C showed the lowest corrosion current density, followed by temper B and the MA-87 alloy. MMC of temper A had the highest corrosion current density. Contrary to the polarization behavior of the MMC, the MA-87 alloy showed a larger passive region.
